**COMPARATIVE PERFORMANCE OF STRUCTURAL LAYERS IN
PAVEMENT SYSTEMS**

**VOLUME I. DESIGN, CONSTRUCTION, AND BEHAVIOR
UNDER TRAFFIC OF PAVEMENT TEST SECTIONS**

ARMY ENGINEER WATERWAYS EXPERIMENT STATION

JUNE 1974

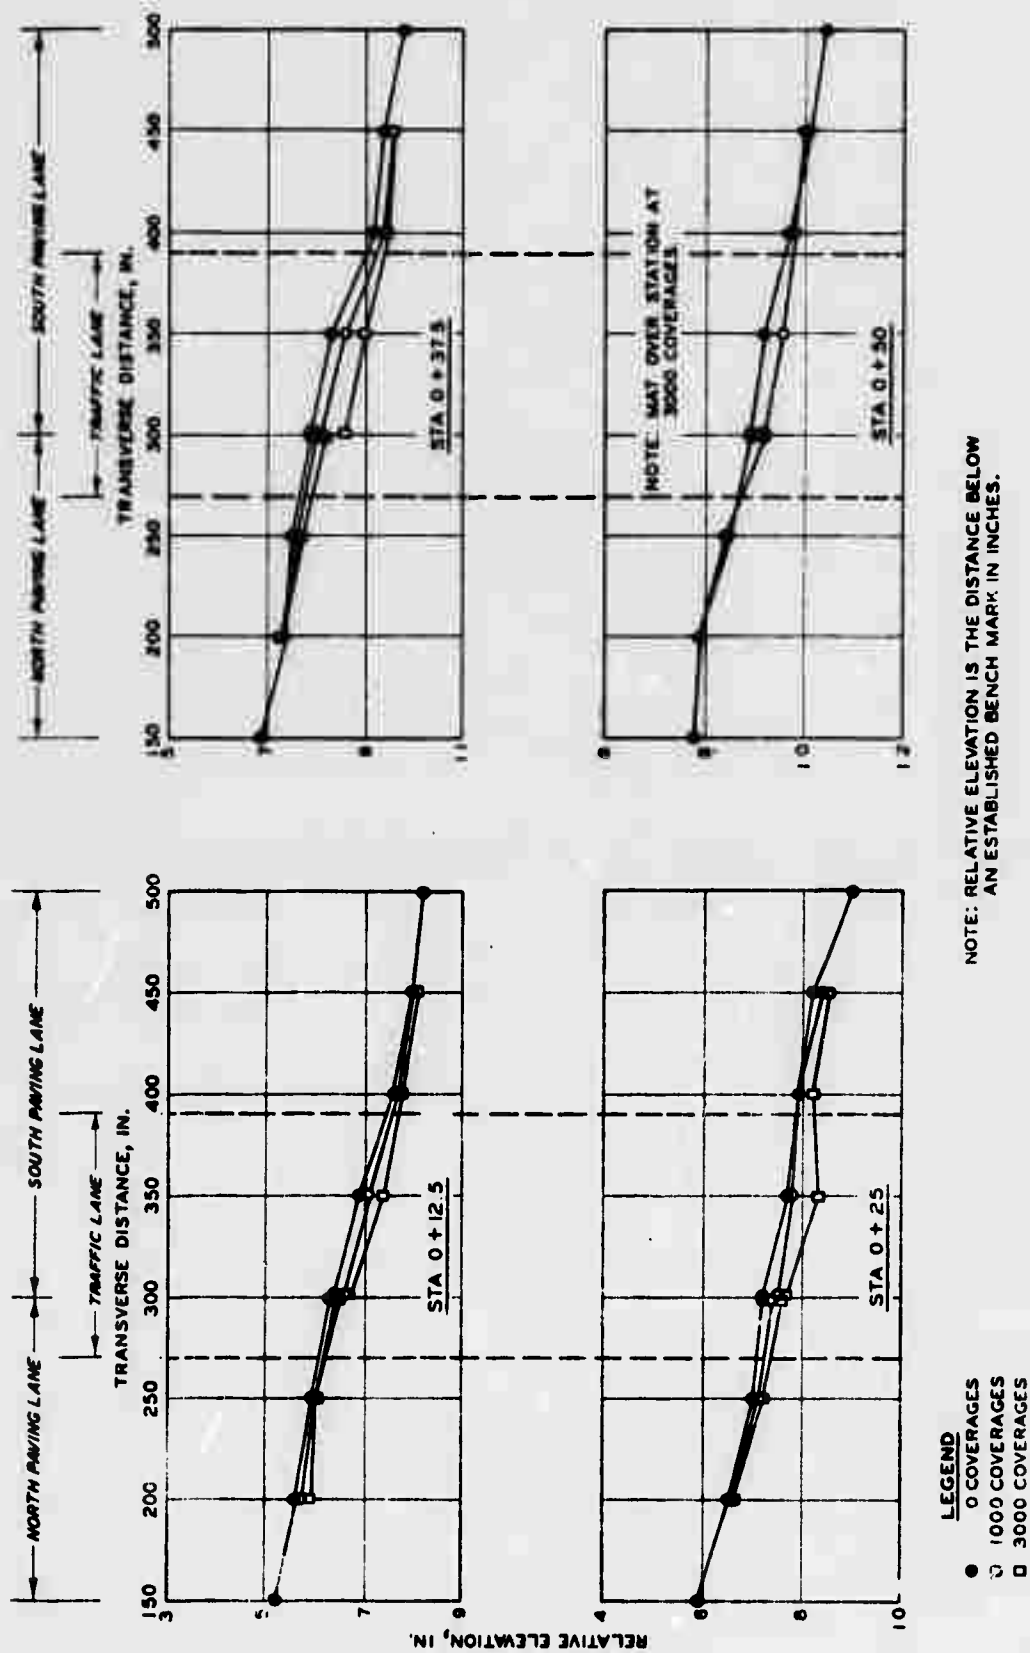
Figure A6. Surface deformation in item 1, lane 1, rigid pavement test section

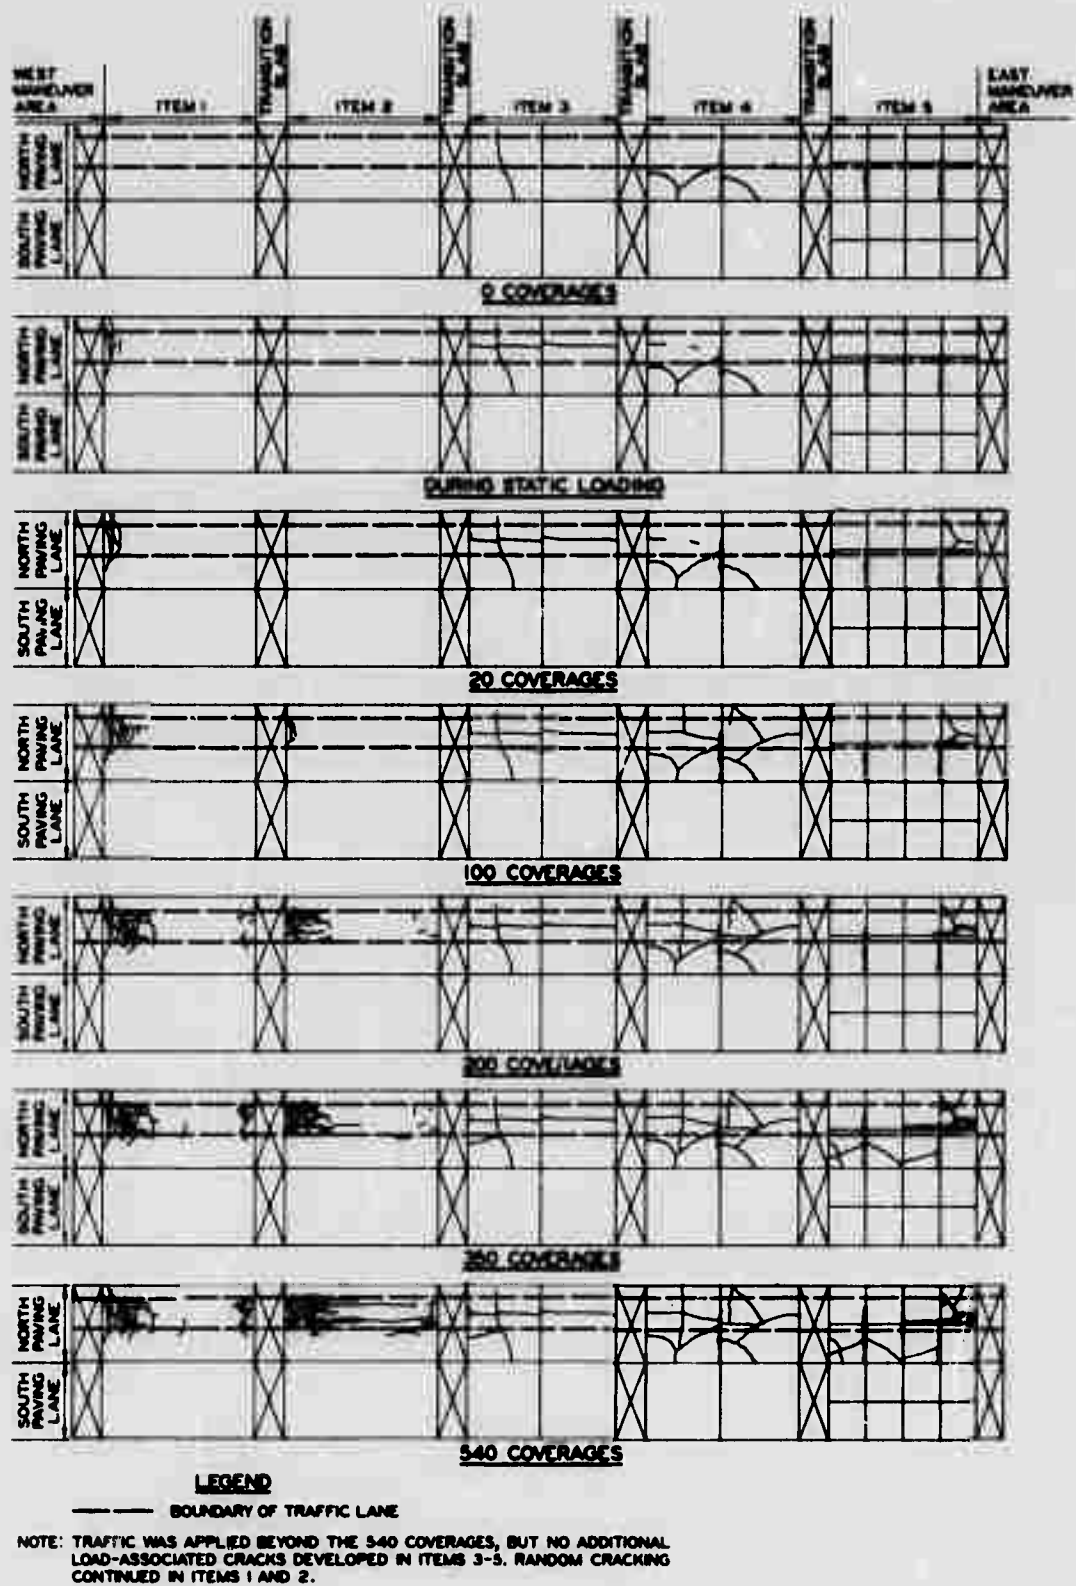
Figure A32. Crack development in lane 2, rigid pavement test section

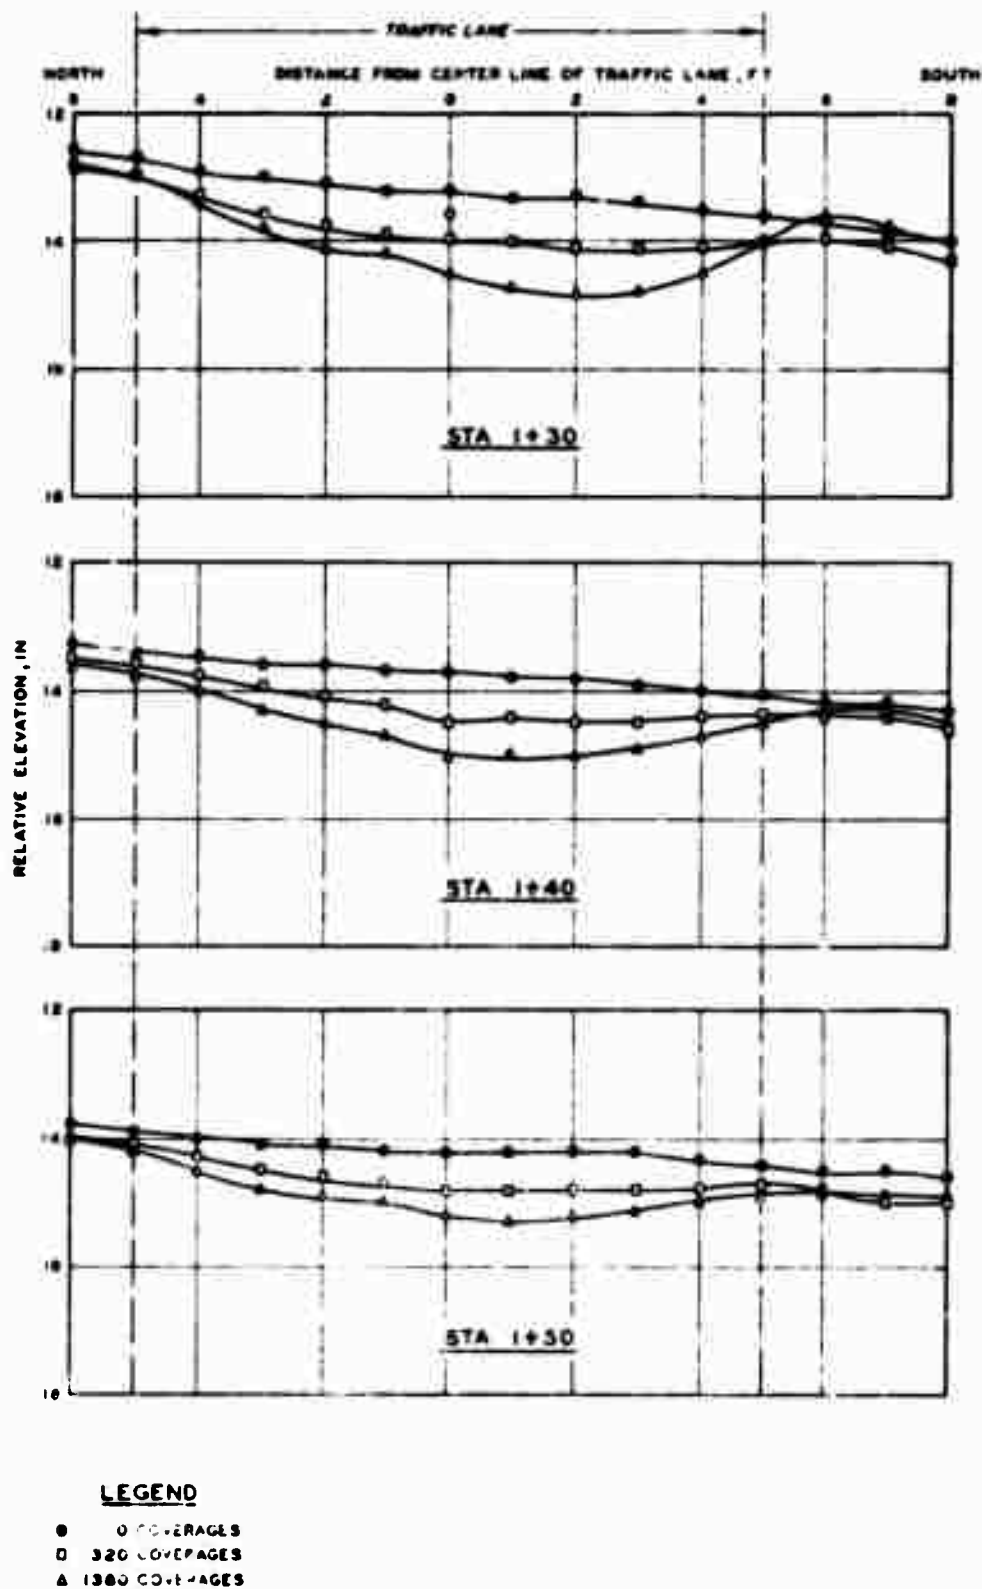
Figure B21. Surface deformation in item 4, lane 1, flexible pavement test section

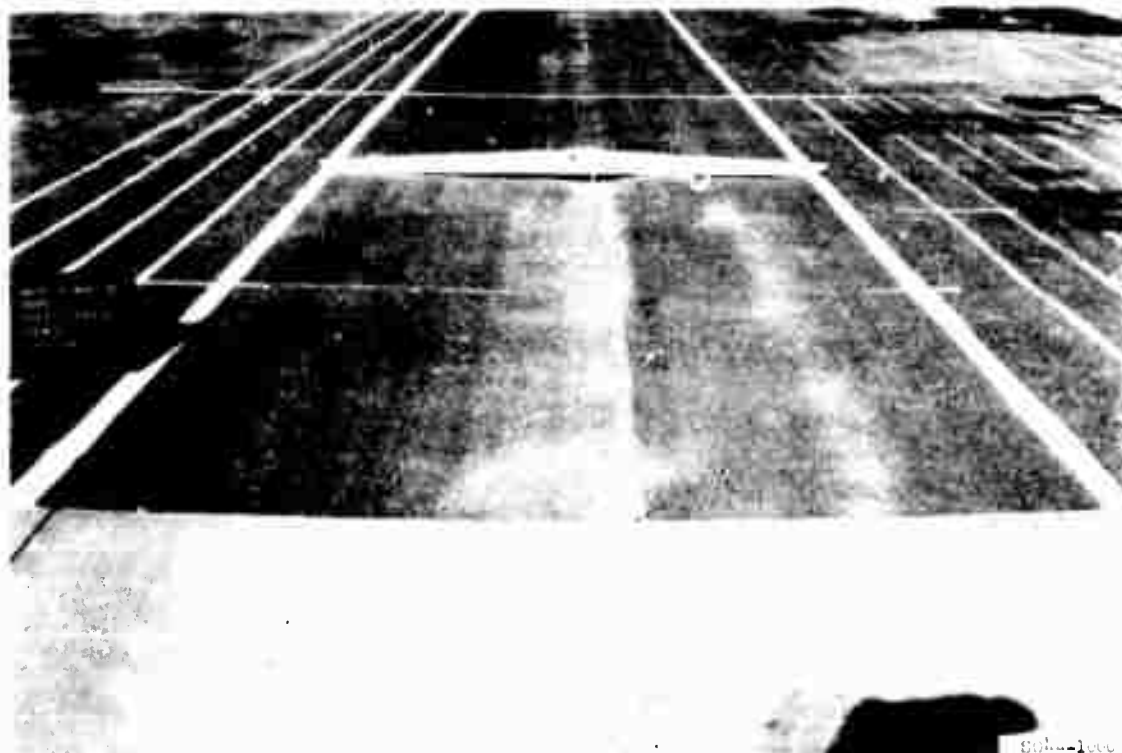
Figure B35. Cracking and deformation in item 4, lane 2, flexible pavement test section, at failure after 120 coverages of 240-kip twin-tandem assembly

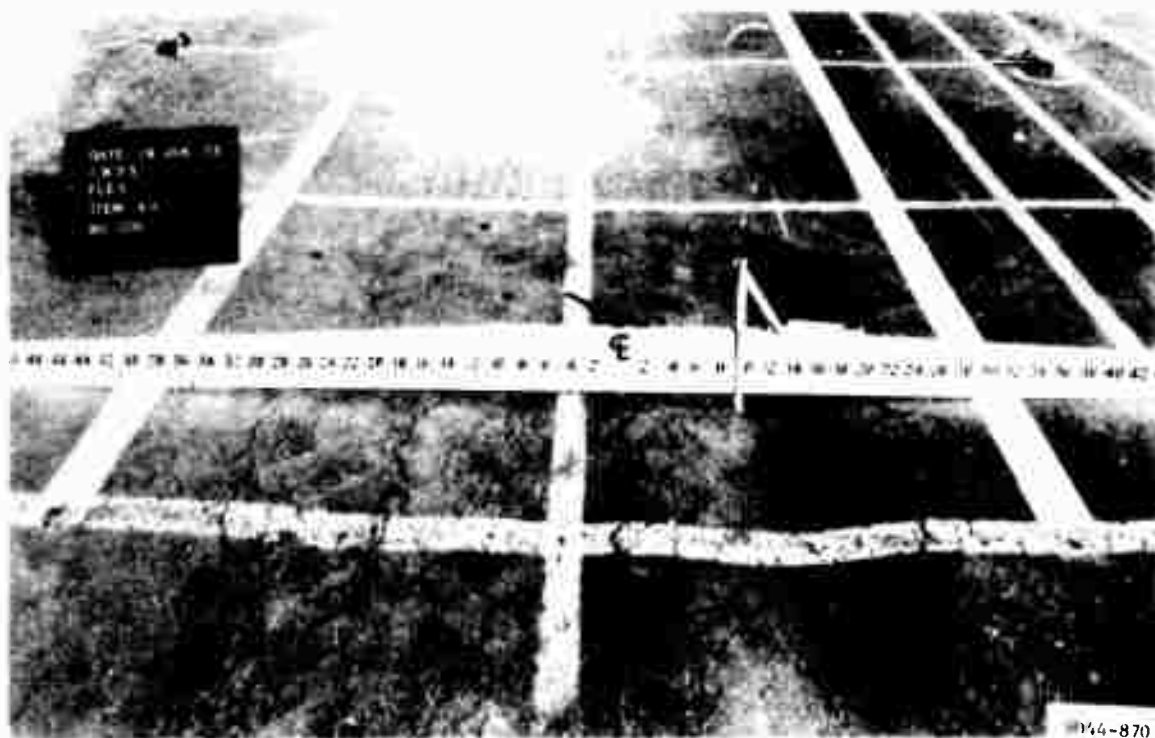
Figure B52. Cracking in subitem 4a, lane 3, flexible pavement test section, after 80 coverages of 50-kip single-wheel assembly

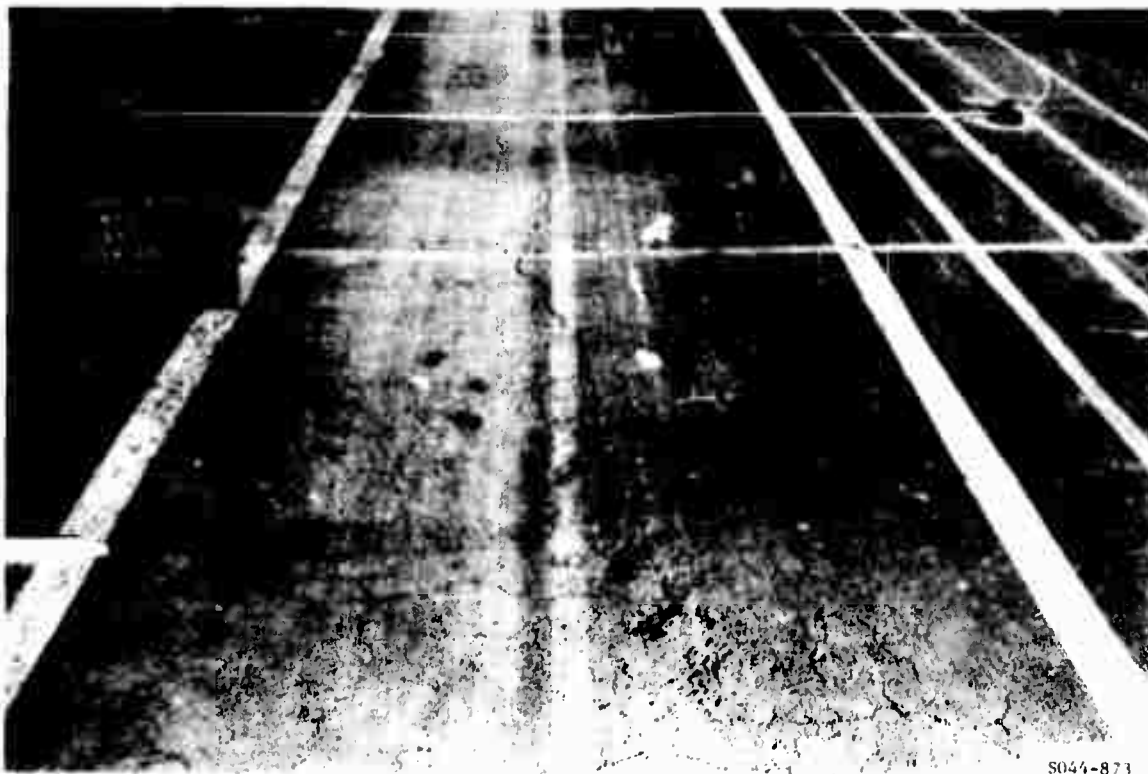
Figure B54. Cracking and deformation in subitem 4b, lane 3, flexible pavement test section, at failure after 170 coverages of 50-kip single-wheel assembly
